Tat's a fact

problem solving

FORLA99215
FORD
LASER BJ
9-1999
4 cylinder

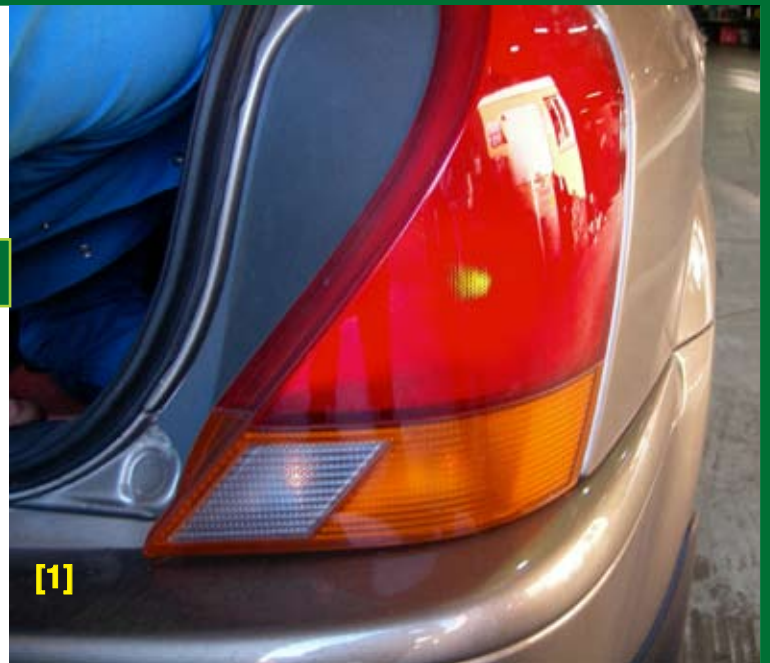
After inspecting the driver side rear lamp assembly and testing its earth connections, it was discovered that the earth circuit had a poor connection to the vehicle body.

This was causing a voltage feed-back to the reverse light circuit back to the auto ECU.

This voltage was seen by the auto ECU as an indication that the vehicle was in reverse gear, therefore causing violent down-shifting.

The removal of the driver's side rear lamp [1], and inspection of the wiring and globe holders [2].

An additional earth cable was run from the vehicle chassis to the globe holders.
