Tat's a fact

problem solving

HOLVX02418
HOLDEN
VX COMMODORE
2-2002
5.7 Ltr V8

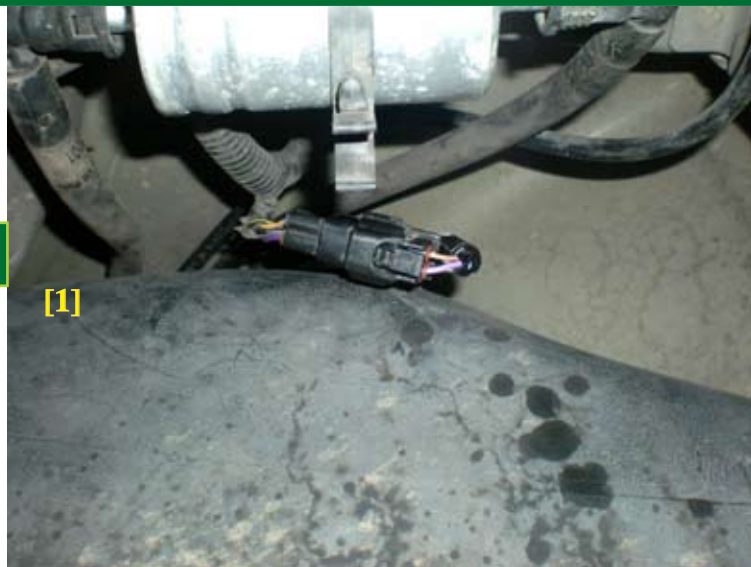
Tracing fuel tank harness back towards the vehicle harness an additional connection was found near the fuel filter [1].

On testing voltage at this connector, it was found that the voltage drop was within the linking harness to the fuel tank.

Replacement of both the main pump assembly and the linking harness.

Linking harness Part No. 92110191

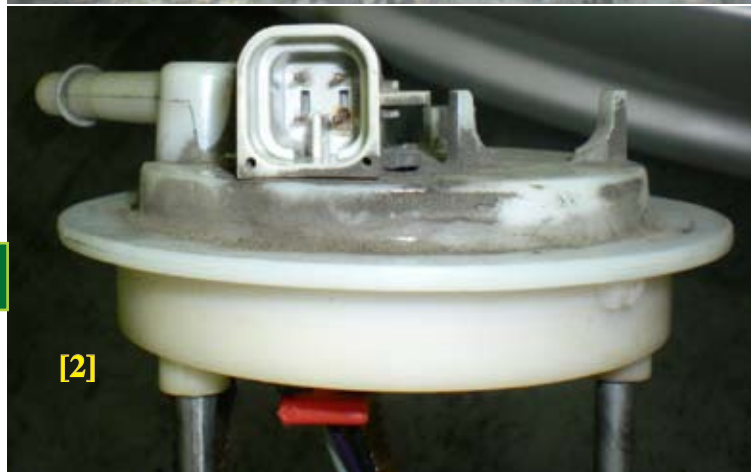
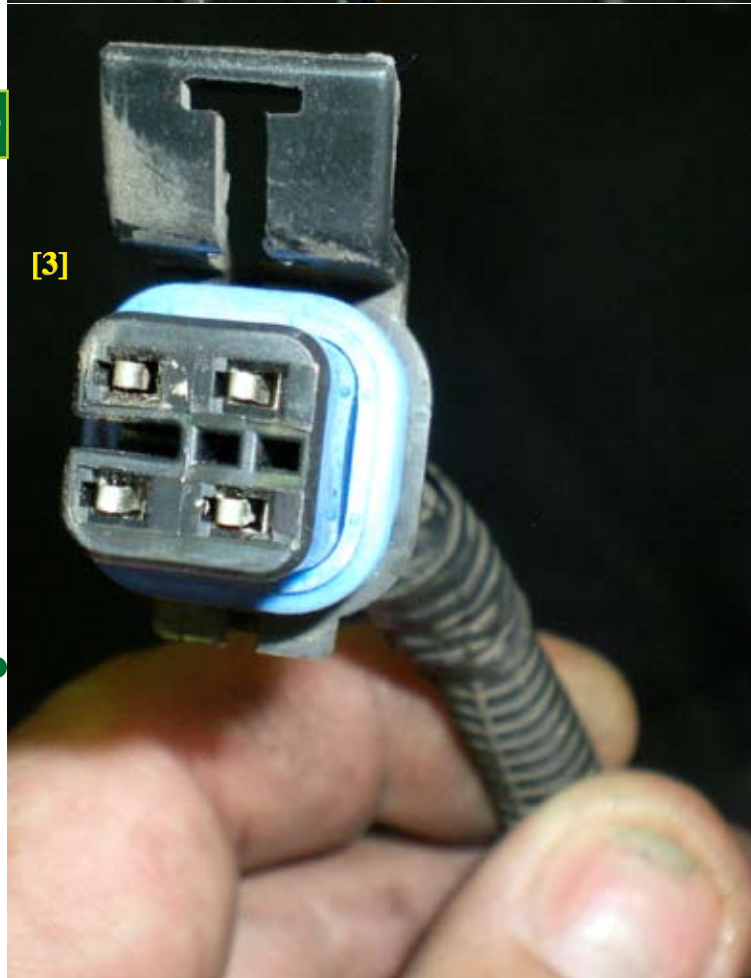
As seen in Pics [2 & 3], the result of high current flow (previously replaced faulty pump) damage is done to the pins in both the pump connector and the additional main harness connector.

Pump and sender unit Part No. 92158012
