# Tat's a fact

problem solving

**NISXT02112**  
**NISSAN**  
**X-TRAIL**  
**2002**  
**4 cylinders**

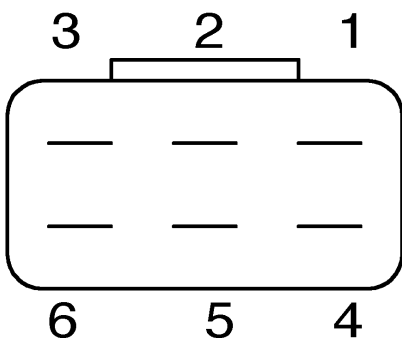
Pins 1,2 and 4 are for sensor 2 and pins 3, 5 and 6 are for sensor 1.  
 The 5 volt reference pins are 6 and 4.  
 Ground signal are 1 and 3.  
 Throttle pedal position signal are from pins 2 and 5.  
 View is into TPS

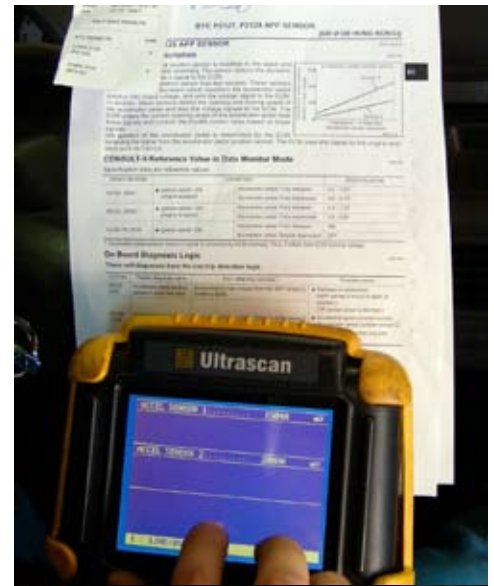
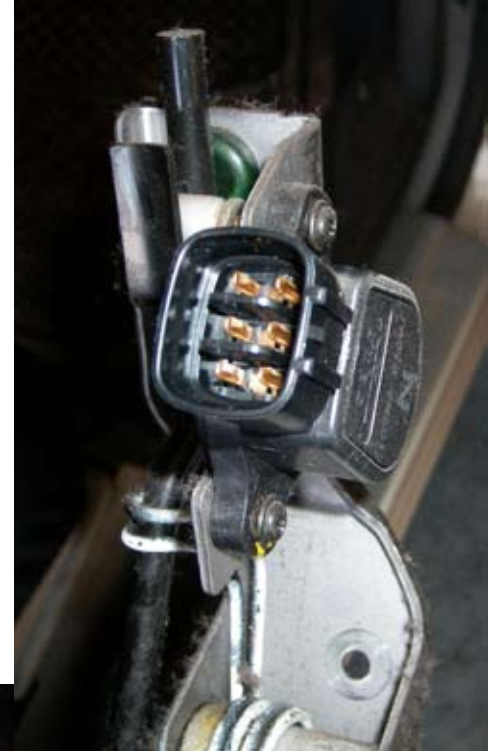
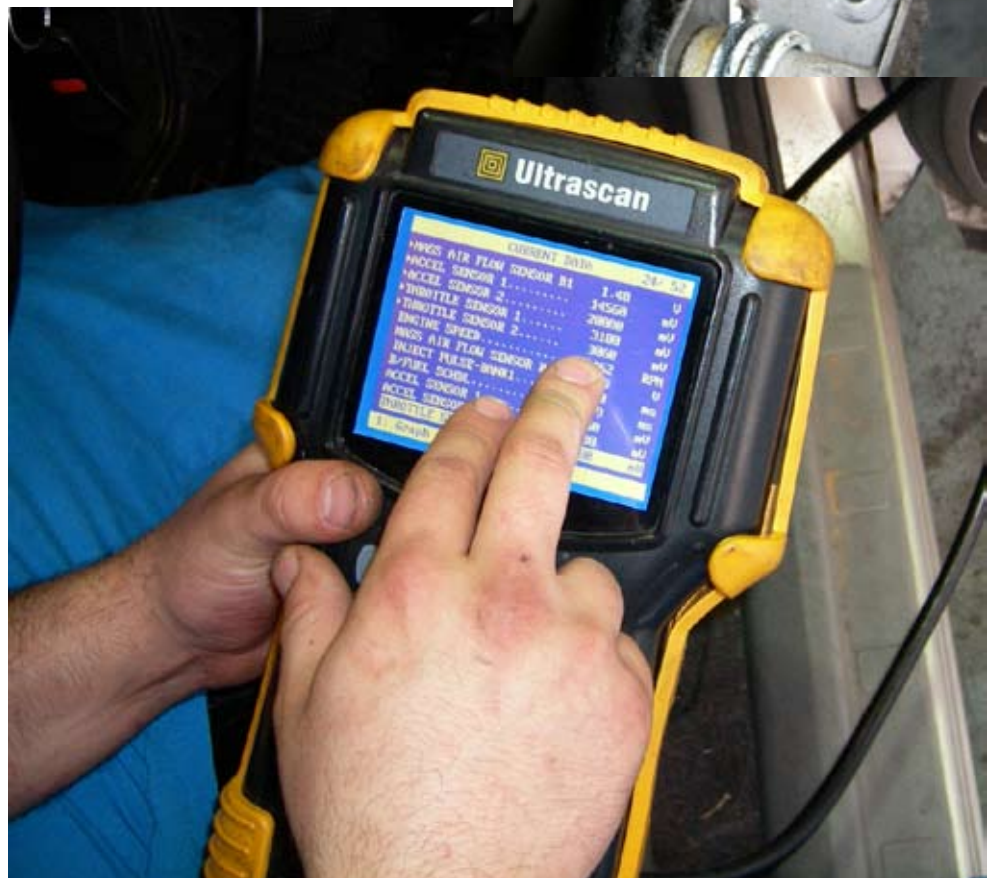
Due to sensor 2 not working correctly at certain throttle positions, the ECU picked up the low voltage as compared to

sensor 1.

- 4) After checking with an oscilloscope, it was found that the signal from sensor two was faulty.

Fit new accelerator pedal position sensor,  
**Part number 1800-8H706**  
 Lever complete-accel
