problem solving

SAA9094414
SAAB 900S
10-1994
B234i 4 cylinder

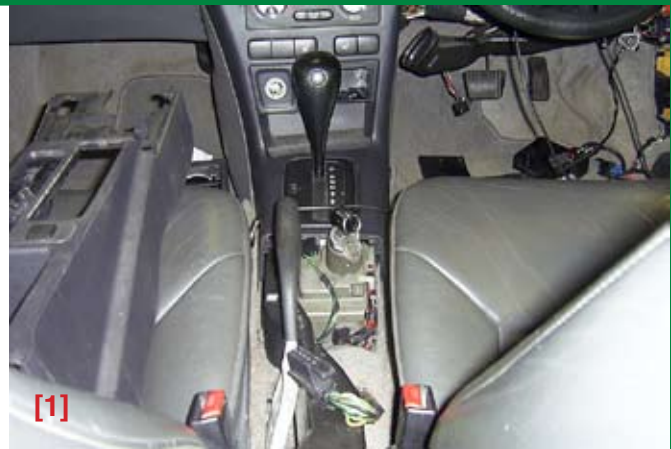
[1]

ignition switch. Removed ignition switch and testing showed ignition 1 (main) supply to ECU and dash instrumentation.

Ignition switch contacts burnt and causing excessive voltage drop.

Replace electrical section of ignition switch.

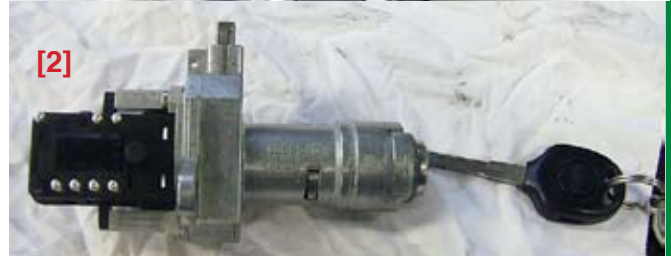
[2]

Excessive voltage drop across ignition switch. Opening up switch and inspection confirmed poor connections to ignition feed 1.

Contact switch Part No. 4946307
