**TOYPR00112**  
**TOYOTA**  
**PRADO**  
**7-2000**  
**3.4 Ltr V6**

## Customer complaint

Lack of power especially down low, and high fuel consumption.

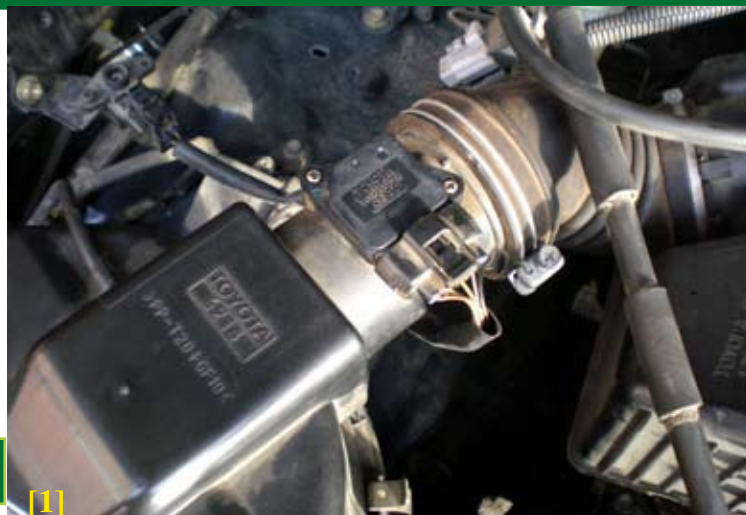
Remove air intake to throttle body [1] and remove air mass meter and inspect.

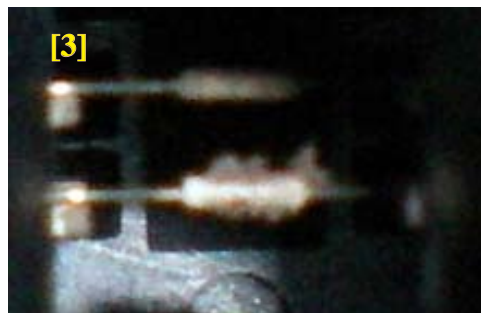
**NOTE:** Close-up pic [3] shows

the contamination of the air mass meter sensors.
