Tat's a fact

problem solving

FORLA99215
FORD
LASER BJ
9-1999
4 cylinder

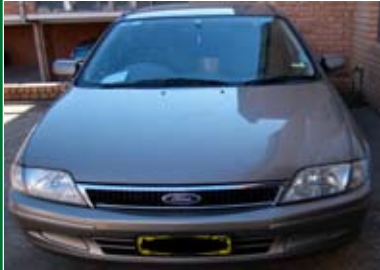
After inspecting the driver side rear lamp assembly and testing its earth connections, it was discovered that the earth circuit had a poor connection to the vehicle body.

This was causing a voltage feed-back to the reverse light circuit back to the auto ECU.

This voltage was seen by the auto ECU as an indication that the vehicle was in reverse gear, therefore causing violent down-shifting.

The removal of the driver's side rear lamp [1], and inspection of the wiring and globe holders [2].

An additional earth cable was run from the vehicle chassis to the globe holders.

Removal of the passenger side light and inspection of the connections is also recommended.
