# Tat's a fact

problem solving

**NISXT02112**  
**NISSAN**  
**X-TRAIL**  
**2002**  
**4 cylinders**

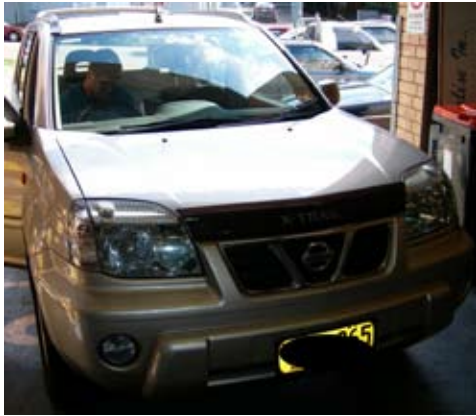
Due to sensor 2 not working correctly at certain throttle positions, the ECU picked up the low voltage as compared to

sensor 1.

When the malfunction is detected, the ECU enters fail-safe mode and the MIL lights up.

Fit new accelerator pedal position sensor,  
**Part number 1800-8H706**  
 Lever complete-accel
