Tat's a fact

problem solving

CITBE044
CITROEN
BERLINGO
07-2004
4 cyl

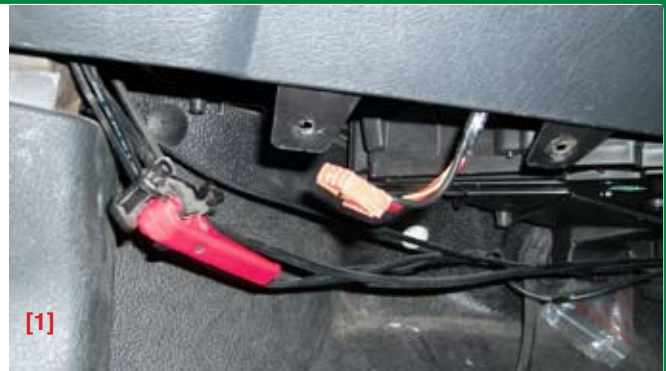
Interior fan unit mounted on passenger side under glove box. [1]

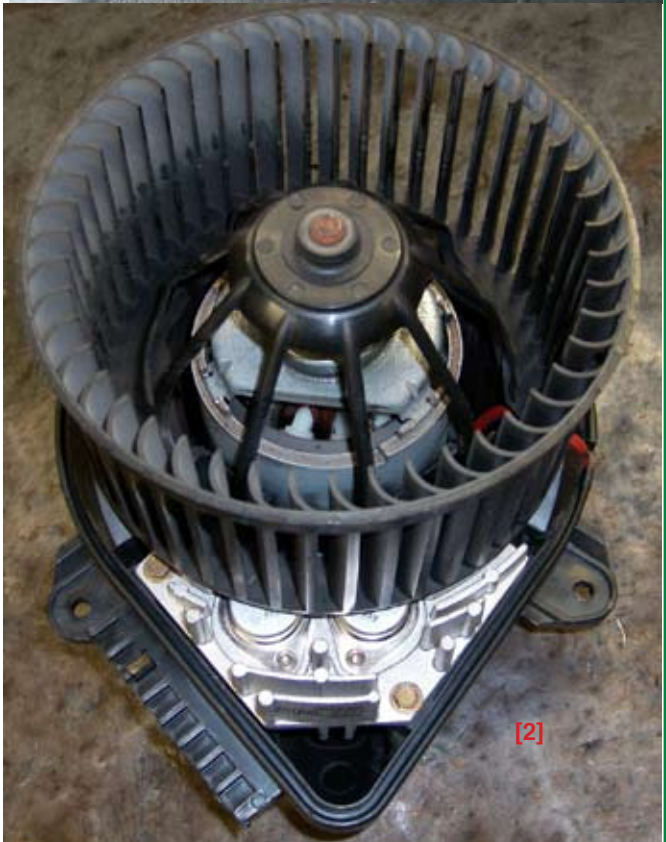
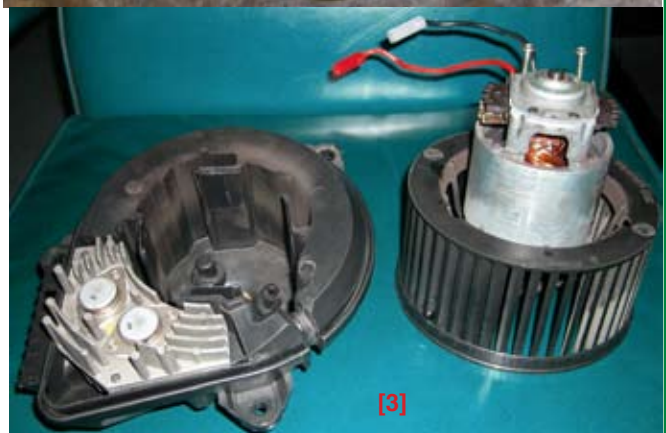
Interior fan has fan speed control amplifier mounted in fan housing [2] & [3]

To test the interior fan input from switch to amplifier, use a digital volt meter and back probe the thin pink wire going into the 4 pin connector. Voltage should vary with fan speed switch movement.

The fan speed amplifier has an internal fault causing fan to run at full speed. The amplifier is available separately. Replacement of fan amplifier.

Replacement of fan amplifier.
