Tat's a fact

HOLAS00110
Holden
Astra City
04/2000
1.8 16V Z18XE

Throttle pedal position sensor.

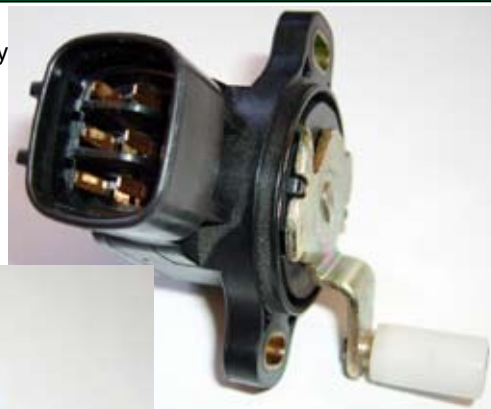
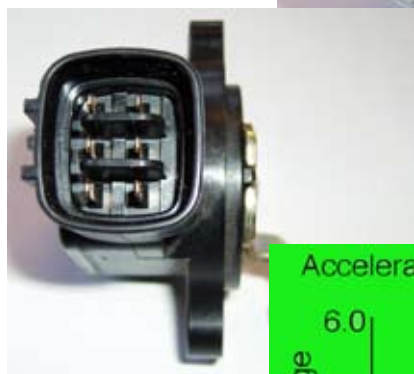
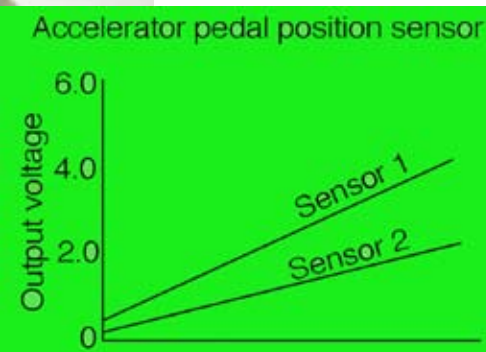
The two built-in potentiometers transform the accelerator pedal position into an output voltage, and transmit this voltage back to the ECM.

The clever part about these sensors is that they also detect the opening and closing speed of the accelerator pedal and feed this information back to the ECM.

The ECM can determine the opening and closing speed by comparing the two sensor voltages to each other at any given time (see diagram).
